Lake Oroville Sedimentation Study – 2002

Geology Section

Department of Water Resources

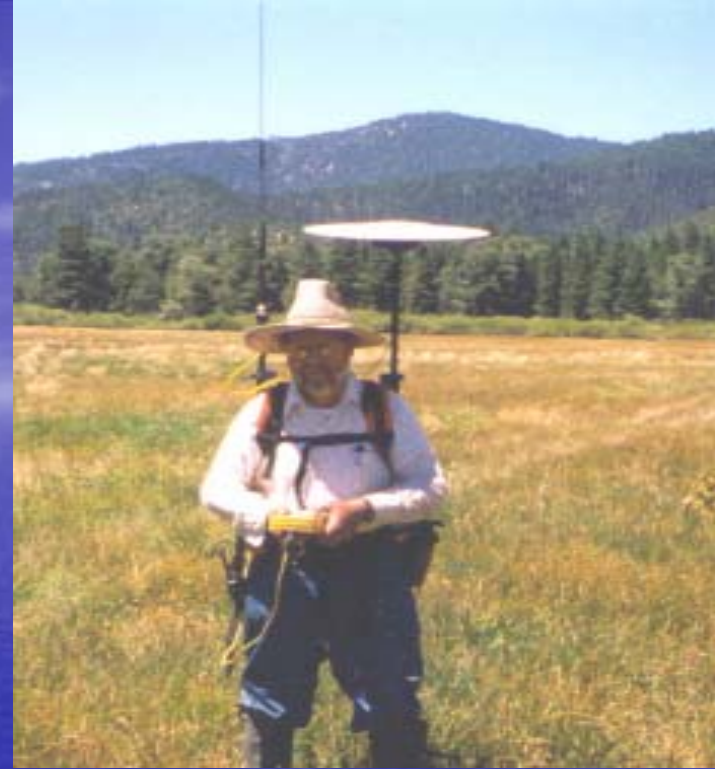
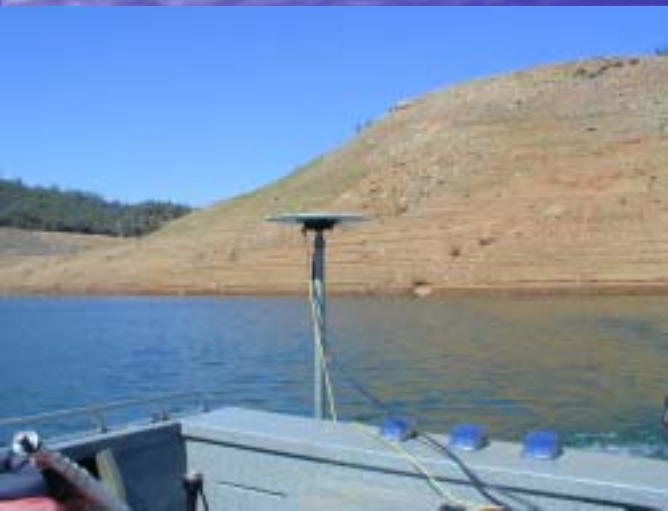
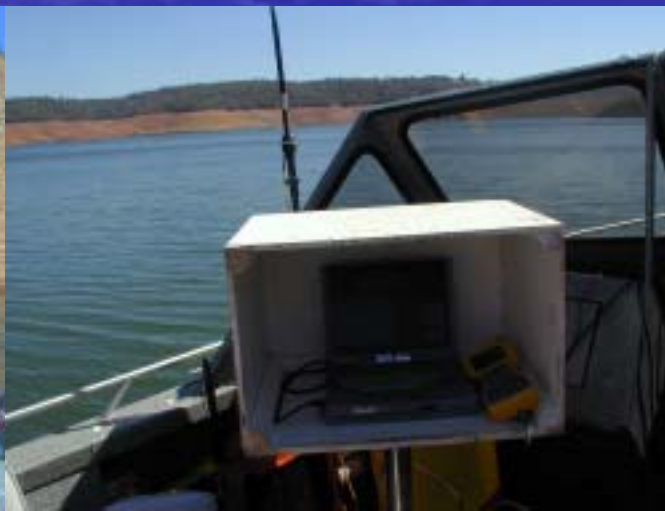
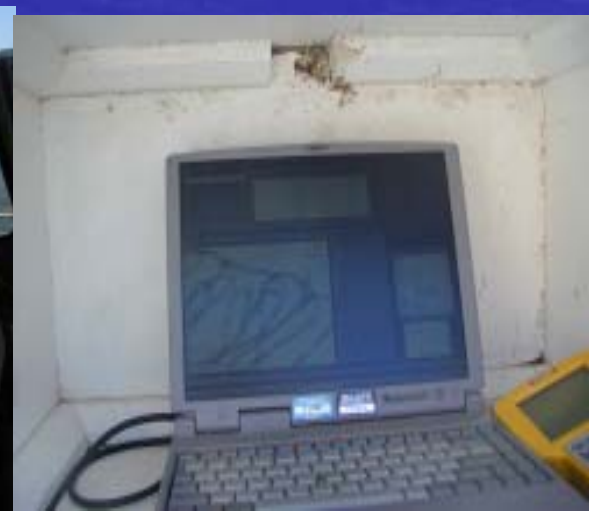
2002 Survey

- GOALS

GPS endpoints for all 24 sections

GPS side slopes

Sound bottom while hooked to GPS

Sound original thalweg trace while hooked to GPS
